DSP56371E Digital Signal Processor

Mask 1L41N

Silicon Errata

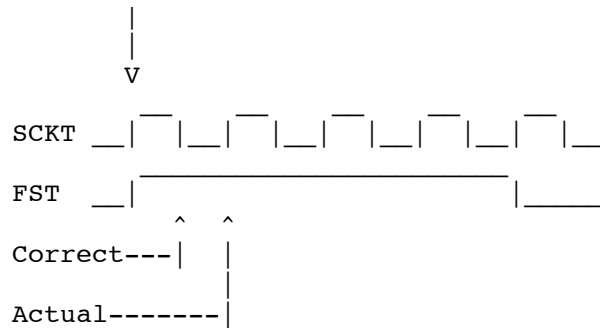
When providing an external word length FST and bit clock (SCKT) to the ESAI transmitter, the transmitter may lose the first bit if the SCKT clock trails the FST. It is important to maintain equal length signal paths for both the FST and SCKT clocks in slave mode.

FST and SCKT should be synchronous as shown by the arrow at the top of the following figure.

The correct time to latch the FST is on the falling edge when the clock polarity bit is clear. However, when SCKT trails FST it is actually being latched on the following rising edge as shown.

If the ESAI inputs the FST rising edge before the SCKT rising edge that generated it then it will "skip" a bit and assume the first bit has already been driven and start to output the second bit. The ESAI would be one bit ahead of the external device.

Workaround: The SCKT clock should be synchronous with the FST clock and should not trail it when the ESAI transmitter is in slave mode.
