By Darci Ernst  
Systems Engineering  
Austin, TX

## Introduction and Background

EB611/D

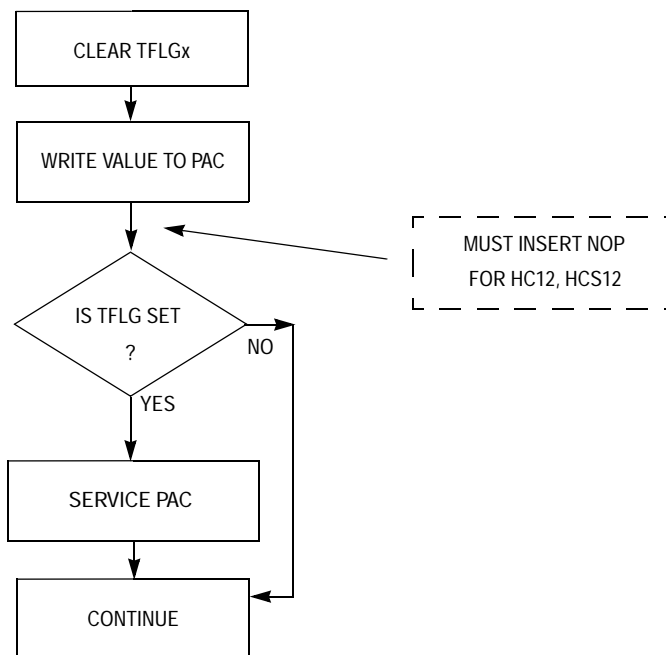
**Figure 1. Flowchart for HC11 Sequence that Fails on HC12**

**Figure 1** shows a flowchart for a successful software check against missing events on the HC11 MCU during a write to the PAC.

The first case has to do with cycle count differences between HC11 and HC12 MCUs. On both families, there is a short delay from when an edge occurs on the pulse accumulator to when the actual accumulator is updated. The timer structure is the same as on older HC11 devices, but identical code running on an HC12 has been shown to occasionally miss events. The event is not really missed. Because the HC12 instruction set requires fewer cycles to execute certain instructions, the HC12 reads the result early, before the bit has been set. See **Figure 2** and note when the CxF bit is set in the TFLG1 register versus when it is read. The HC11 takes two cycles to read the TFLG1 register so the CxF bit is set by the end of the read. The HC12 takes one cycle to read the TFLG1 register so the CxF bit is not set by the end of the read.

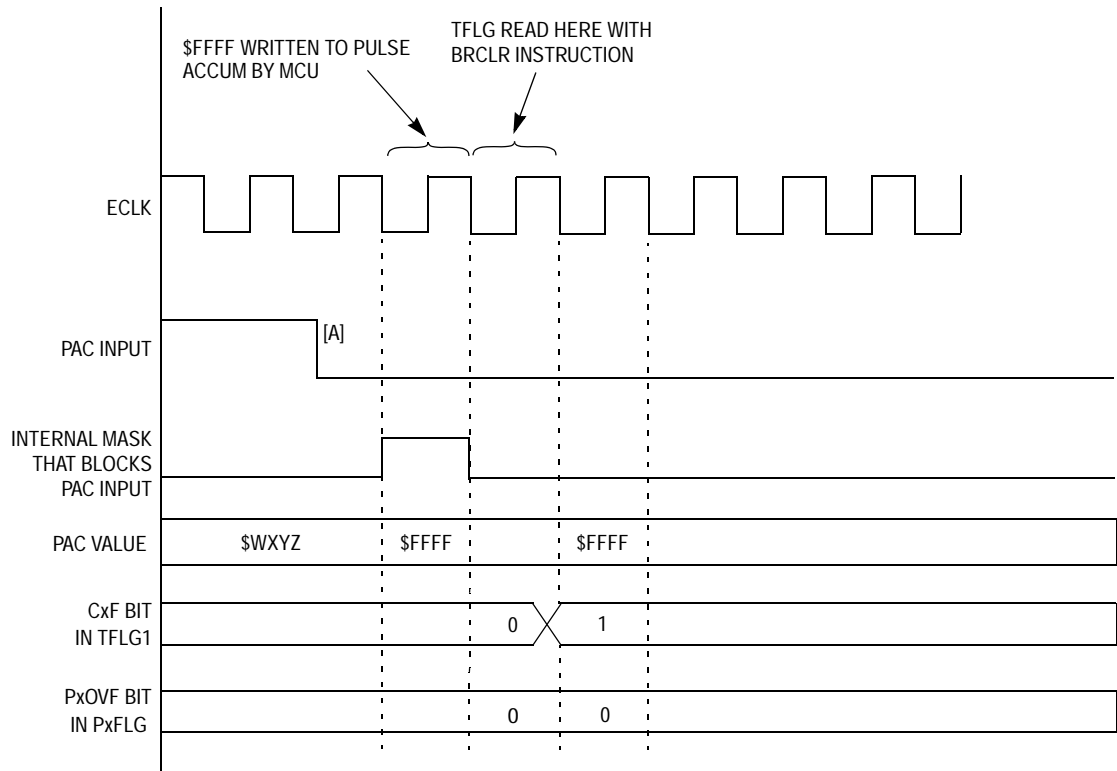
Figure 2. Sequence of Events Required for Missing the Timer Flag in an HC12 or HCS12 MCU(CxF Bit in TFLG1)

The sequence detailed in **Figure 2** shows the required series of events that can cause a timer flag to be missed in the HC12 or HCS12 MCU. Notice at [A] the external PAC input signal arrives in the PAC one clock period later.

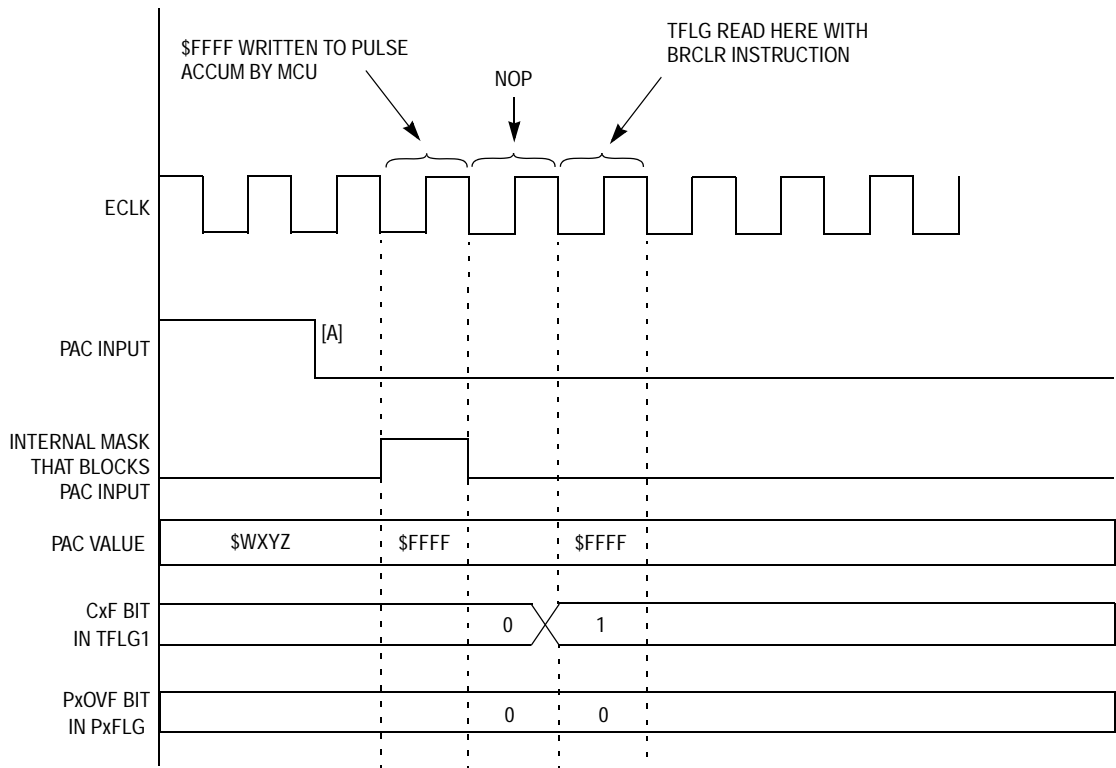
**Figure 3. Solving Conversion Issue by Implementing NOP**

**Figure 3** shows a NOP instruction allowing the TFLG1 assertion prior to being read by the CPU. Notice at [A] the external PAC input signal arrives in the PAC one clock period later.

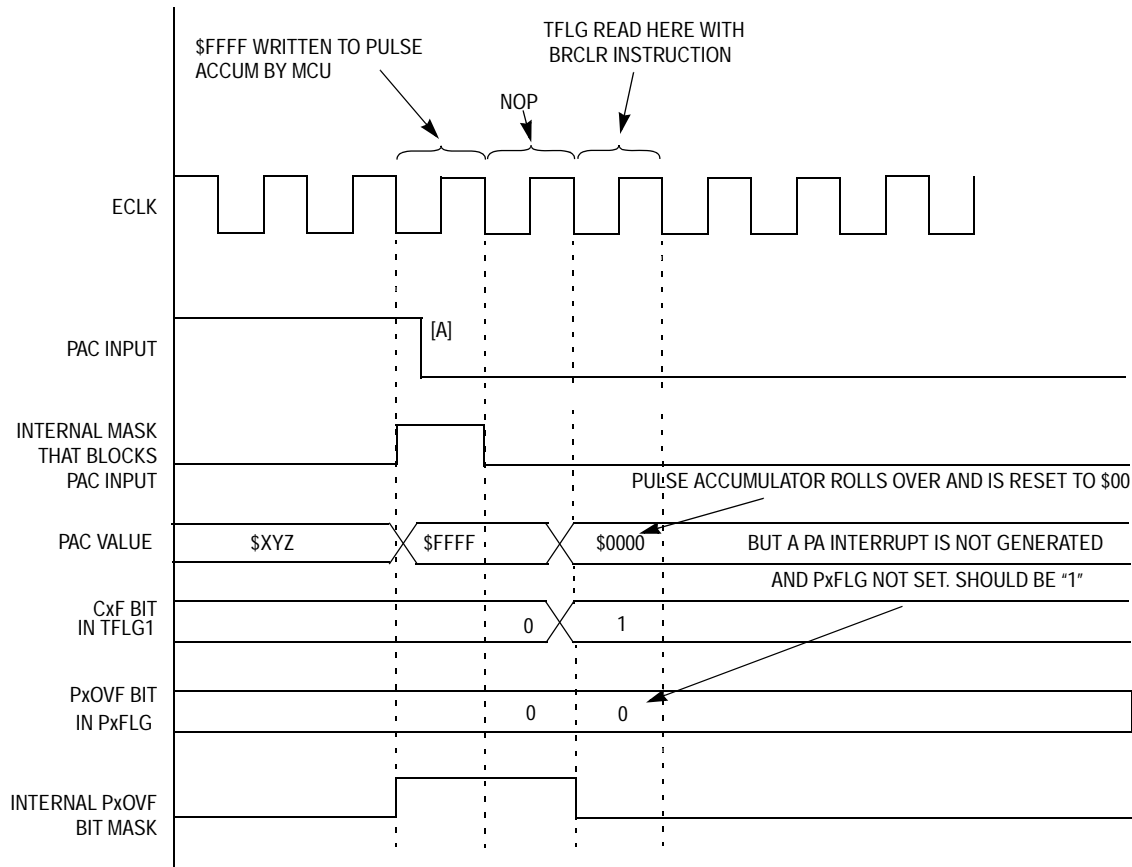
Figure 4. Sequence of Events Required for Missed PA Interrupt Request

The second case (applicable only to the HC12, not the HCS12) is that a somewhat unlikely series of events can cause the pulse accumulator to not generate an overflow interrupt (PAOVI) when the counter goes from \$FF to \$00 (or \$FFFF to \$0000, depending upon mode of operation). This could cause the code to miss an overflow event. Refer to [Figure 4](#); the PxOVF bit does not get set.

[Figure 4](#) shows a NOP instruction allowing the TFLG1 assertion prior to being read by the CPU, but the overflow flag (PxOVF) is still missed. Notice at [A] the external PAC input signal arrives in the PAC one clock period later.

The pulse accumulator logic could fail to generate an interrupt request and/or set the PAOVF when a trigger event occurs at the same time a \$FF value is written to the PACx register (even though the register rolls over to \$00).
