Mask Set Errata for Mask 4L35K

This report applies to mask 4L35K for these products:

- MC68HC908GR16A

Document Number: MSE908GR16A_4L35K
Rev. 0, 12/2010

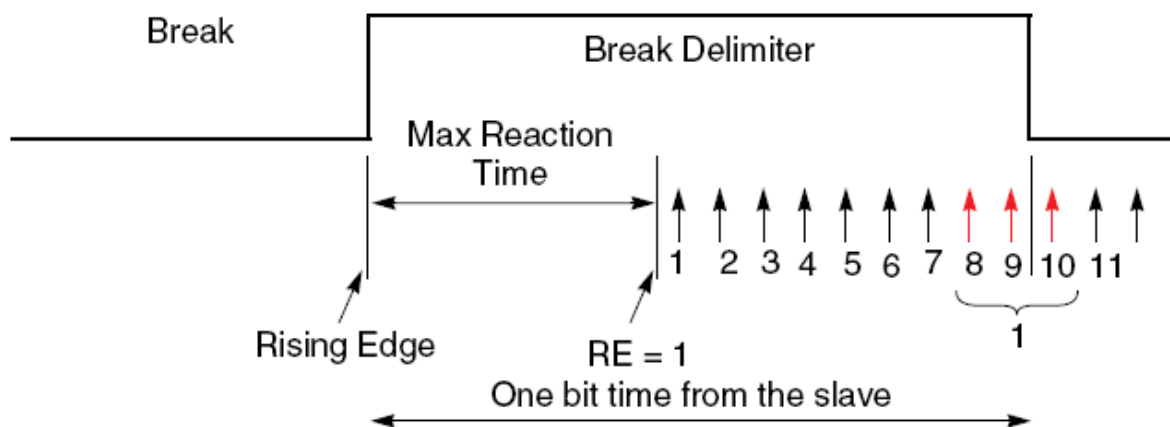
Figure 1. Maximum Time for Other Execution

The time between when the rising edge actually appears on the receive pin and when the receiver is switched back on is finite and is governed by the timing of the falling edge of the delimiter. The receiver must be switched back on no later than 9/16th of a bit time before the end of the delimiter. See figure below.

From this figure, we also see that the "Maximum Reaction Time" is 7/16th slave bit-time.

One bit time at 19200 bps is 52.1 μs.
The LIN 1.3 specification indicates the slave can run at ±14% and the master at ±0.5% of the nominal baudrate. The smallest bit-time the slave might observe is (accounting for accumulated timing errors of a slow slave and fast master):
(100%– 14.5%) x (52.1 μs) = (0.855) x (52.1 μs) = 44.5 μs
The Maximum Reaction Time for this example system is 7/16 x (44.5 μs) = 19.47 μs.
From the instant the rising edge appears on the receive pin (detected via the arbiter AFIN bit or a timer interrupt), the software has to switch the receiver OFF and back ON within 19.47 μs.
